# Manhole Inspection Summary

Manhole # S33K\_\_017MH

Insp Date: **1/9/09 10:03 AM**

**Location** Address: **rear 150 s. sharp st**

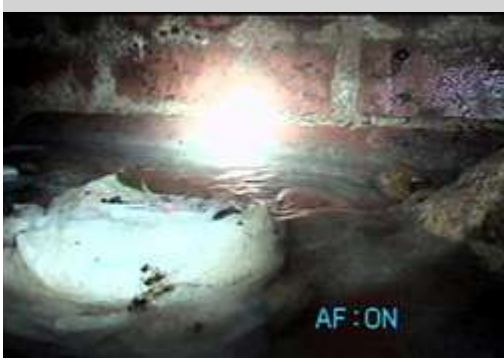
Defect 3

channel debris

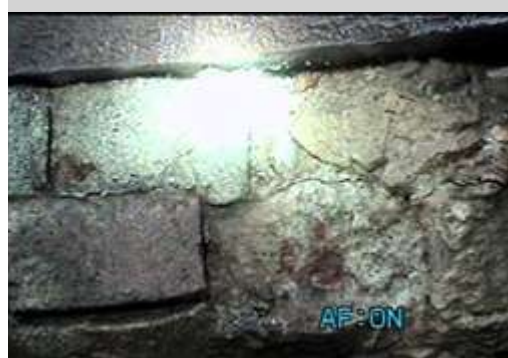
Defect 2

Condition: ☐ Sound ☐ Cracked ☐ Root Intrusion ☐ Loose Brick ☒ **Deteriorated**

chimney deteriorated at frame joint

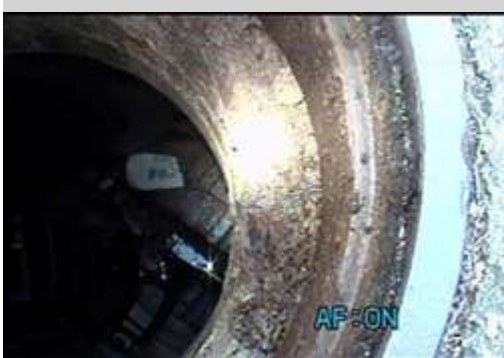
Defect 1

**Frame** Offset: **2.5** (in.) Condition: ☒ Sound ☐ Cracked ☐ Leaks

frame offset 2.5 inches

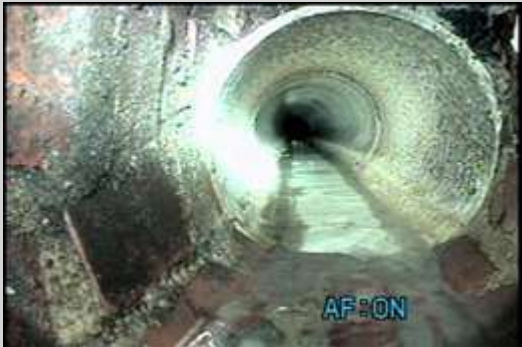
12 O'Clock Outflow

8 in. Circular Gravity Sewer  
Pipe Out @ 12 OClock

Invert Depth: 9.33 (ft.) Flow Characteristics: Fast

Deposits: ☒ None ☐ Mud ☐ Sludge ☐ Debris ☐ Grease

Infiltration: None Pipe Seal Cond: Unknown

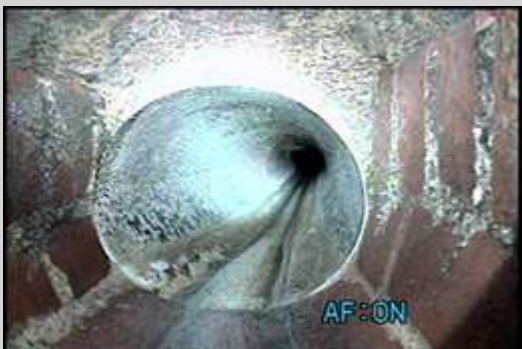
6 O'Clock Inflow

8 in. Circular Gravity Sewer  
Pipe In @ 6 OClock

Invert Depth: 9.30 (ft.) Flow Characteristics: Fast

Deposits: ☒ None ☐ Mud ☐ Sludge ☐ Debris ☐ Grease

Infiltration: None Pipe Seal Cond: Unknown

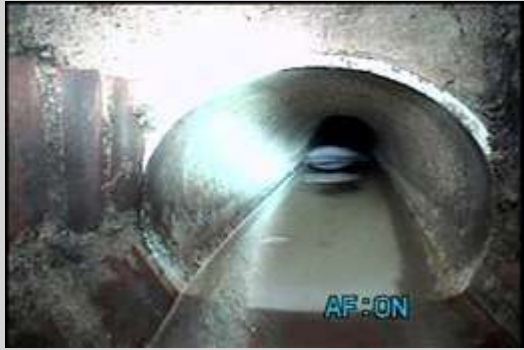
9 O'Clock Inflow

8 in. Circular Gravity Sewer

Pipe In @ 9 O'Clock

Invert Depth: **9.16** (ft.) Flow Characteristics: **Fast**

Deposits: ☒ None ☐ Mud ☐ Sludge ☐ Debris ☐ Grease

Infiltration: **None** Pipe Seal Cond: **Unknown**
